Coating for Protection Against Corrosion, Abrasion and Chemical Attack

5111

Belzona 5111 (Ceramic Cladding) is a two-component coating designed for the long-term protection of metallic surfaces and masonry against physical, chemical and bacterial attack.

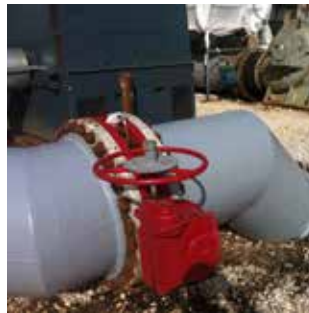
Pipe after

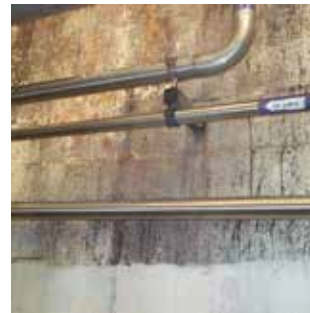
Wall before
